Portage Creek Sediment Remediation Project Kalamazoo, Michigan

Pre-Sediment Removal Structure Feature Assessment
Removal Areas SA1-A, SA1-B and SA1-C

F&V Project Number: 809930
May, 2013

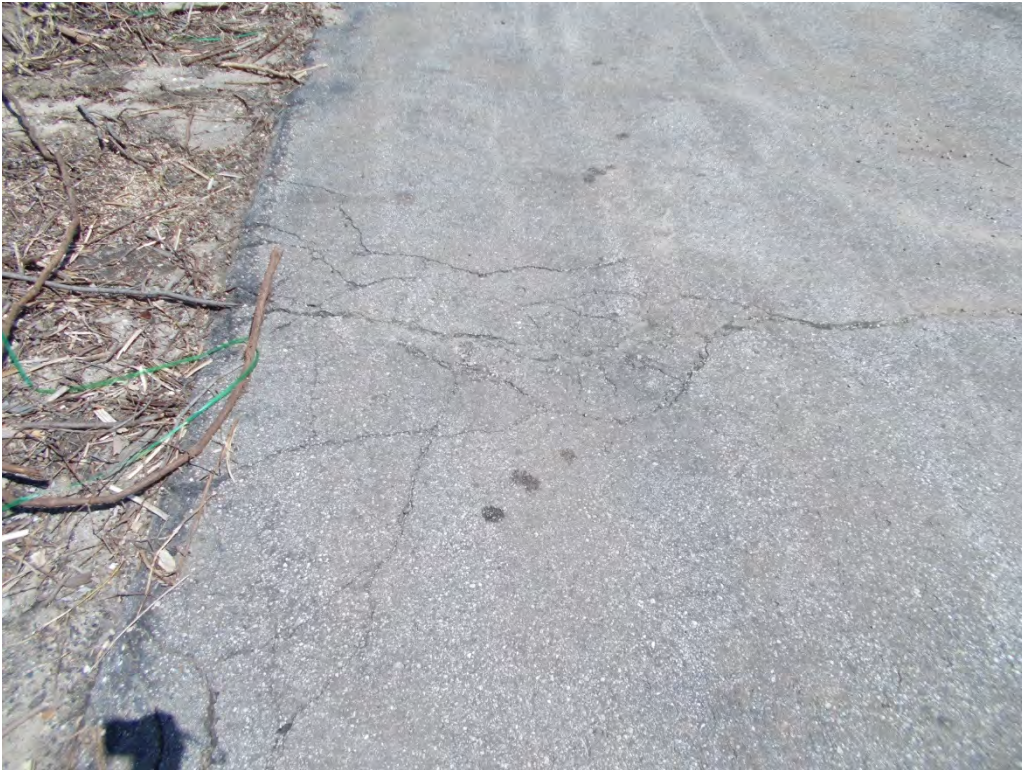
Alligator cracking near edge of pavement

- Repair or replace damaged areas of pavement as required.

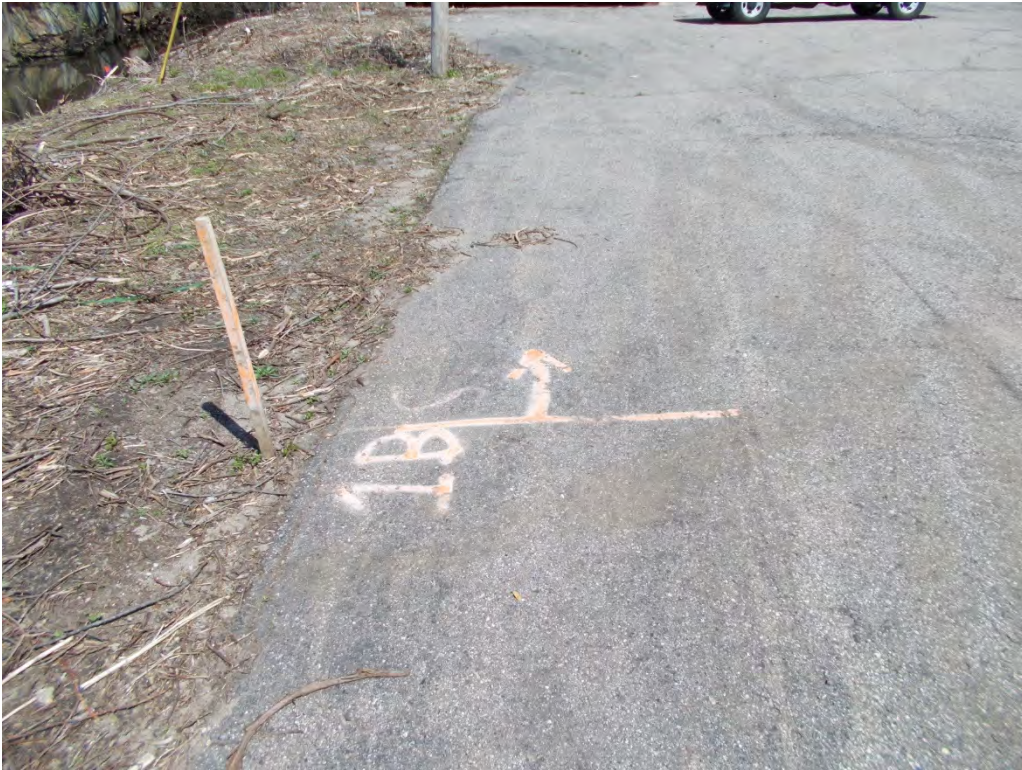
Pavement at south end of SA1-B

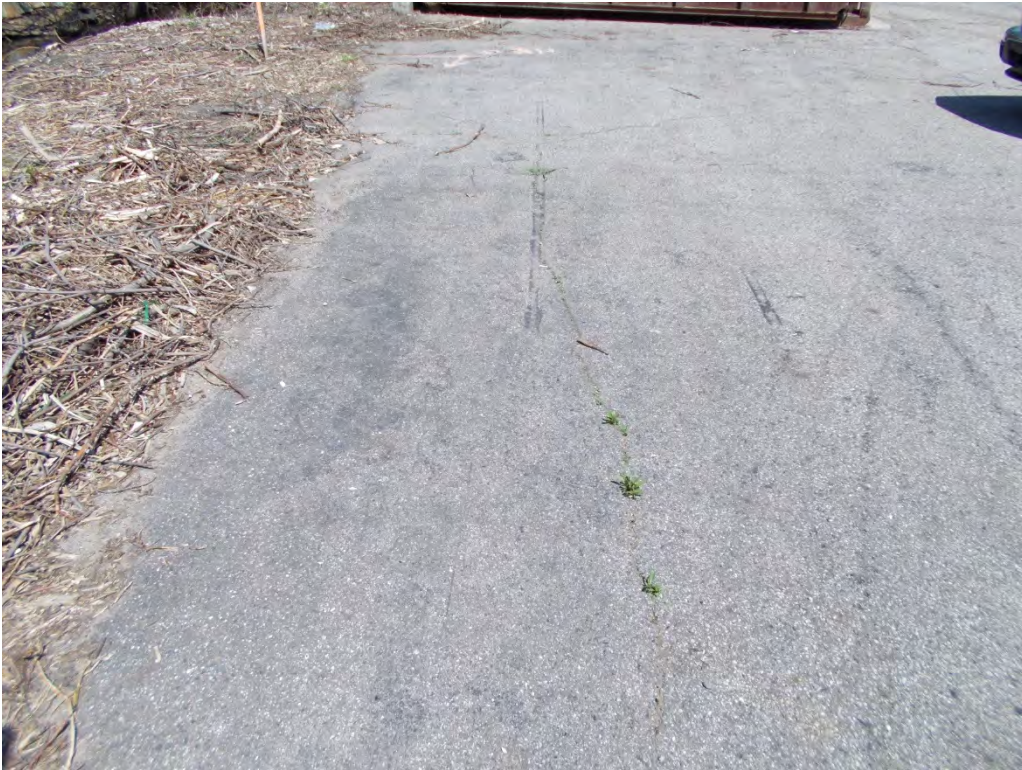
Vegetation growth in cracking

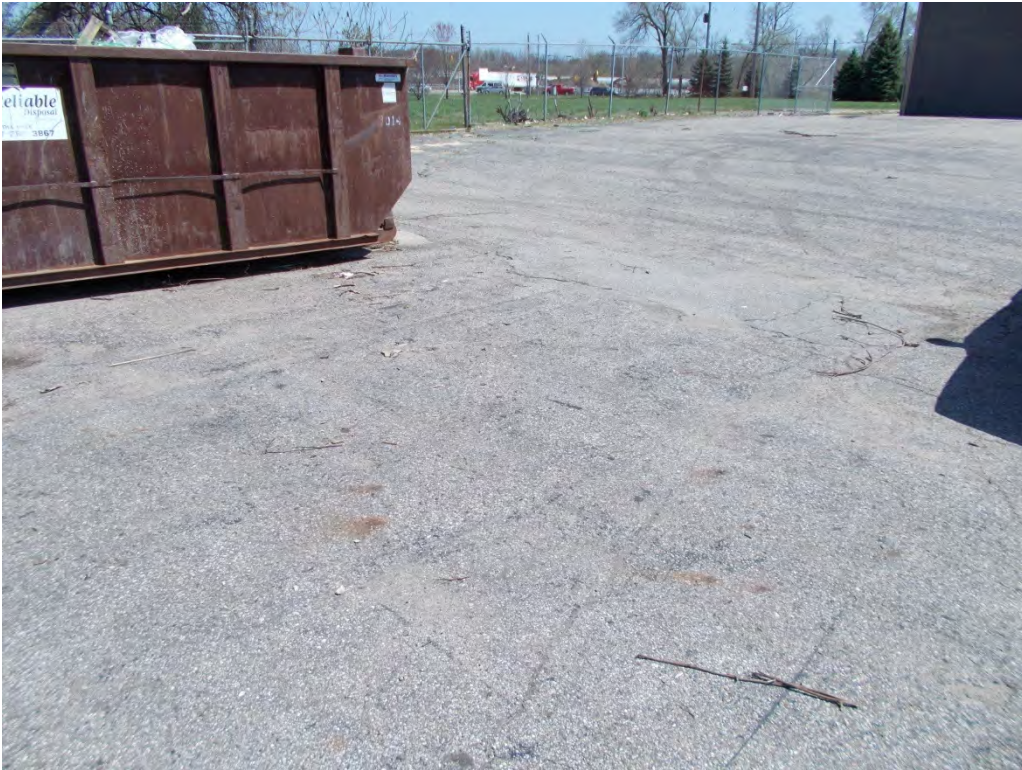
Random cracking in pavement

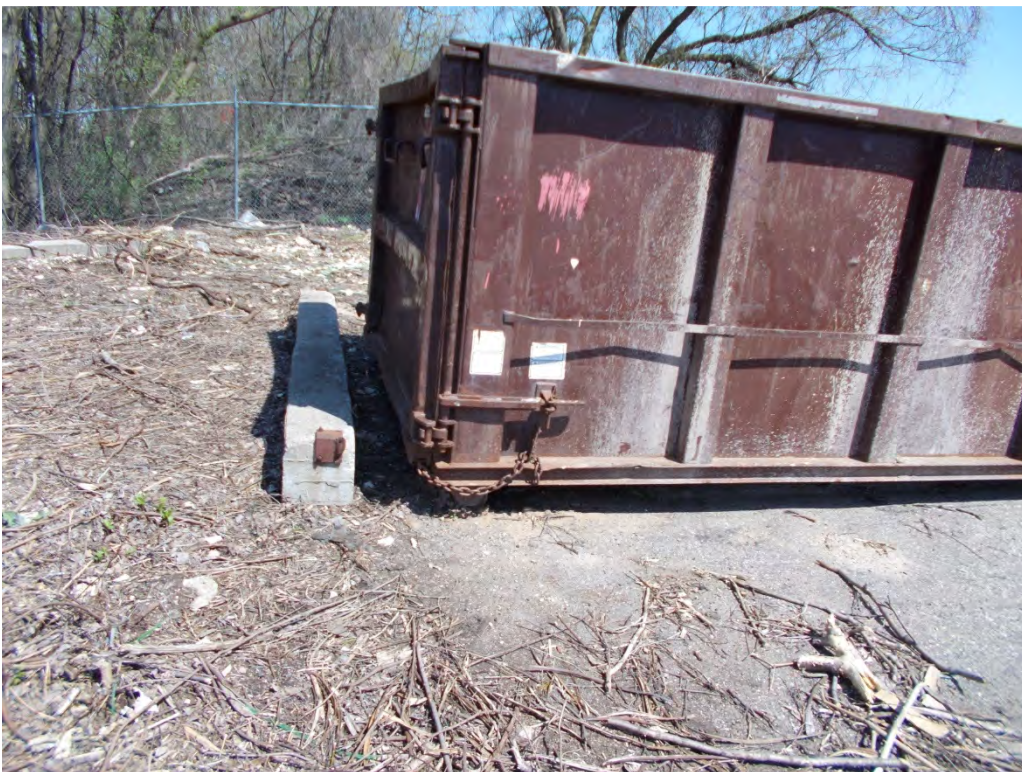
Concrete bumper and commercial dumpster north of SA1-B

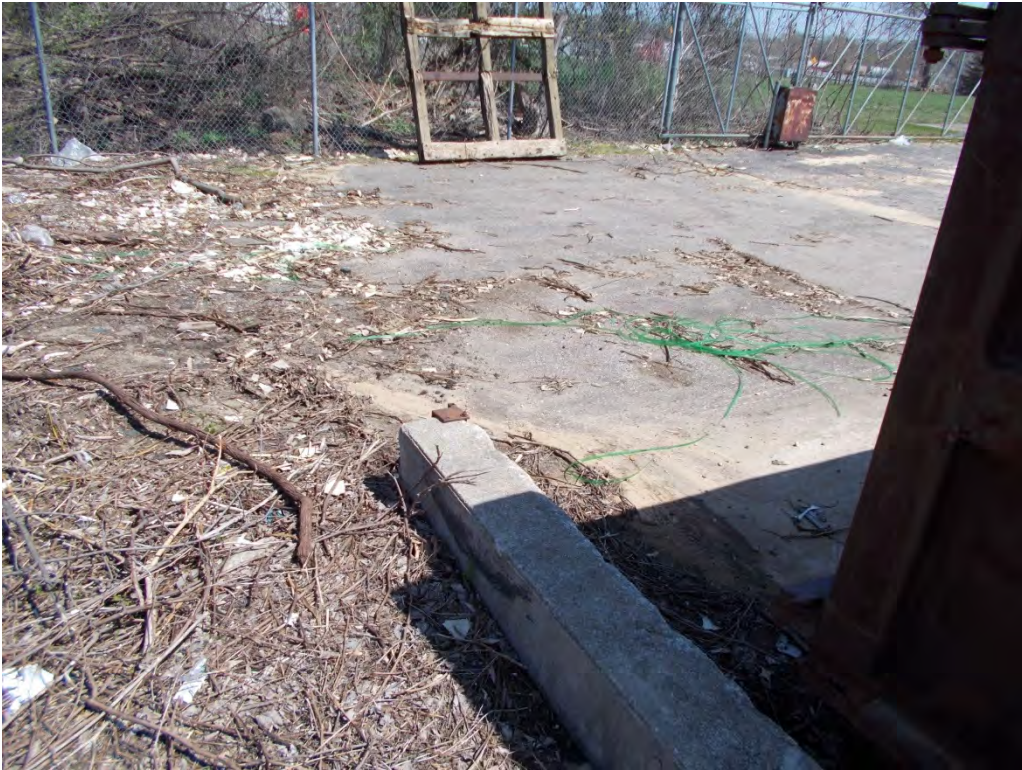
View of pavement north of SA1-B

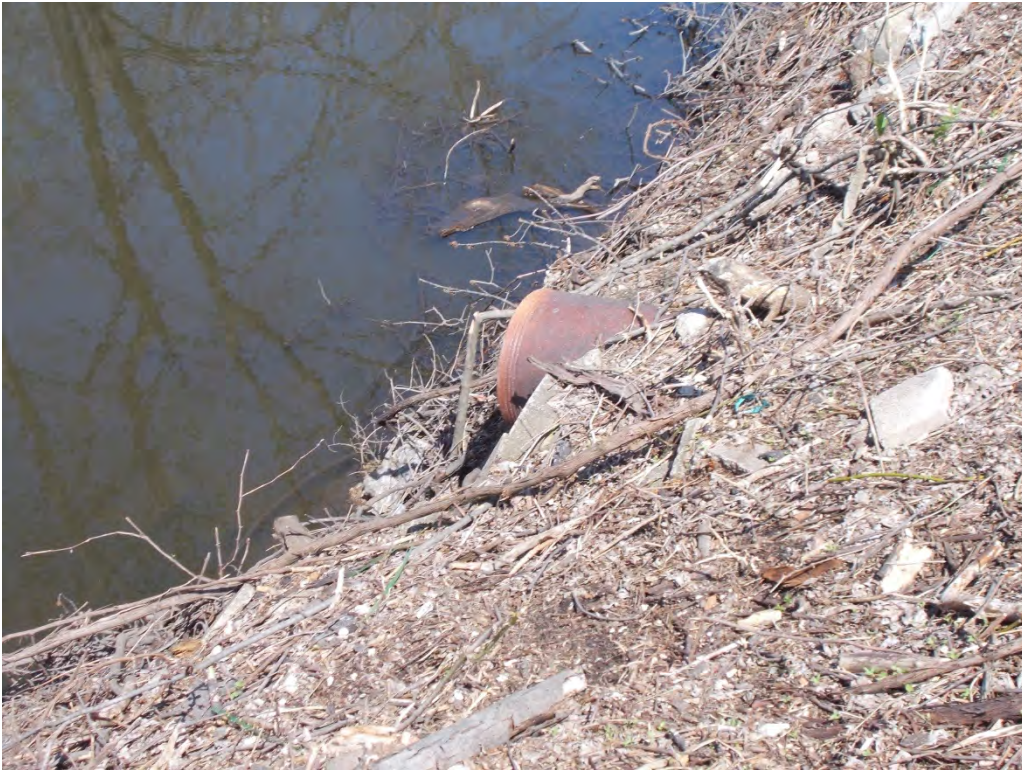
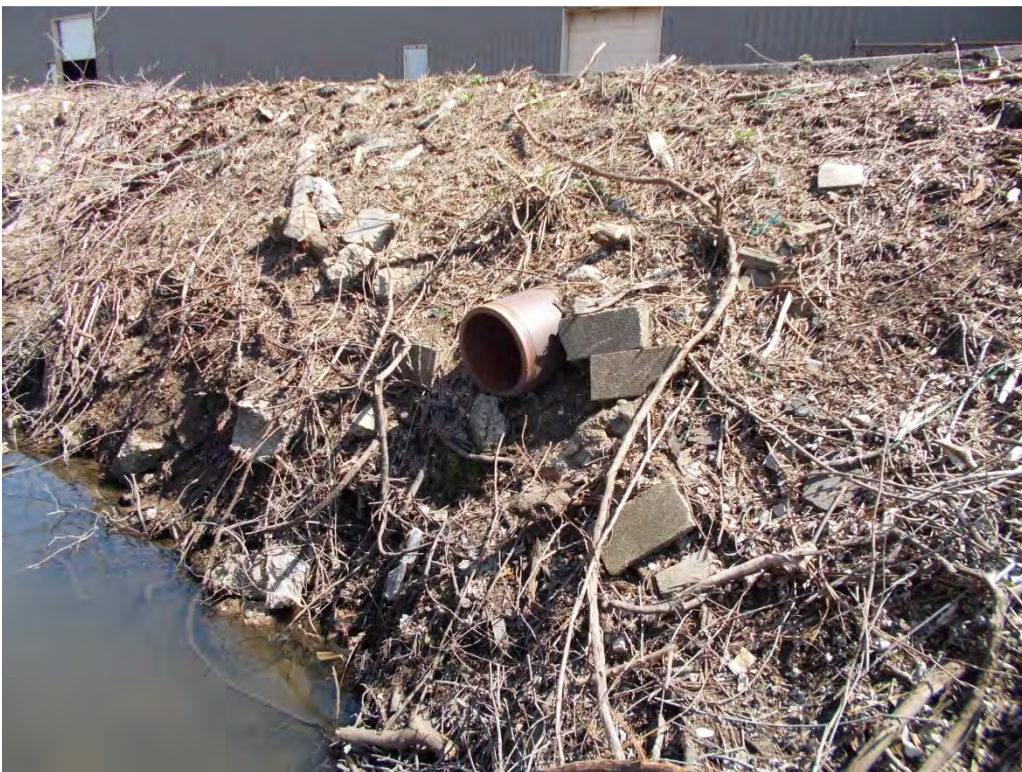
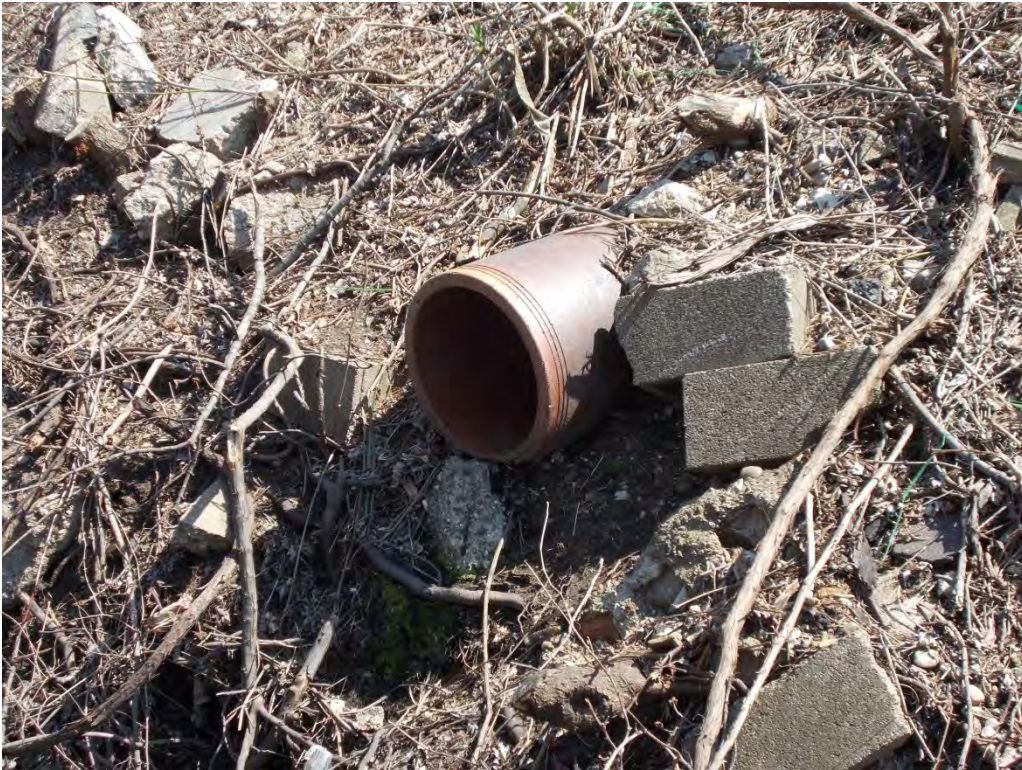
- The outlet is surrounded by the remains of a suspected concrete block headwall.
- Moderate slope erosion was noted around the outlet.
- The pipe is in fair condition. The bottom of pipe is cracked and spalling at the exposed end.

Outlet viewed from the upper bank

View of the outlet from the channel

Close-up view of outlet

- This structure is located south of the southern limits of SA1-B and should be protected from inadvertent damage during sediment removal.

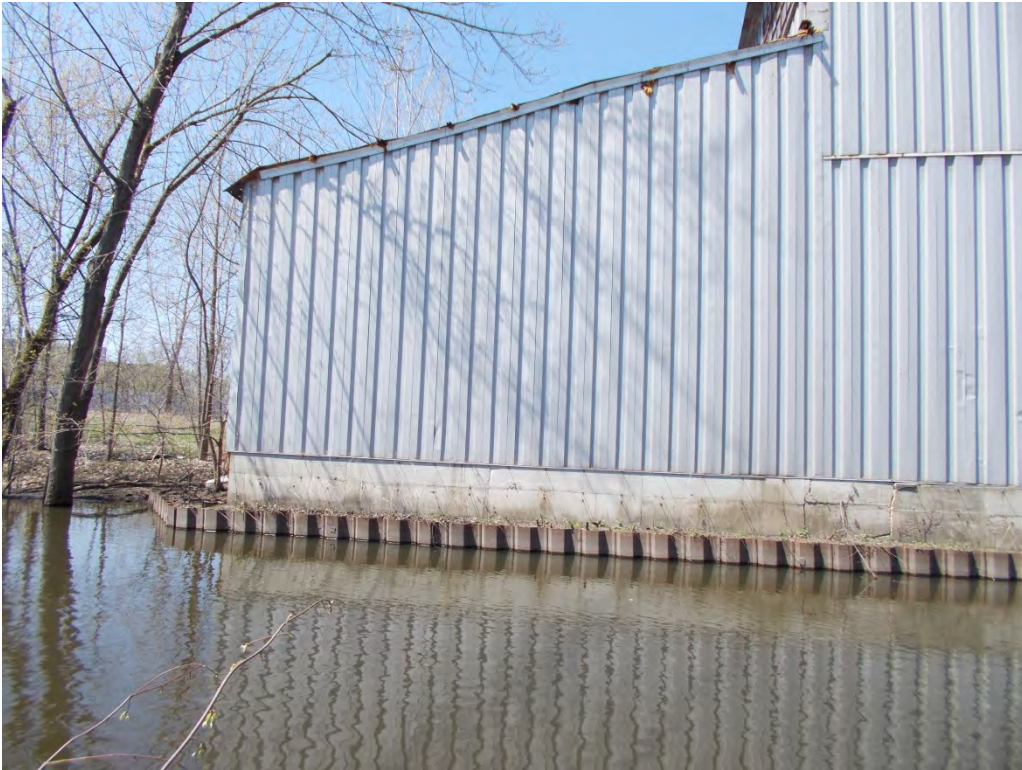
View of south end of structure from east bank

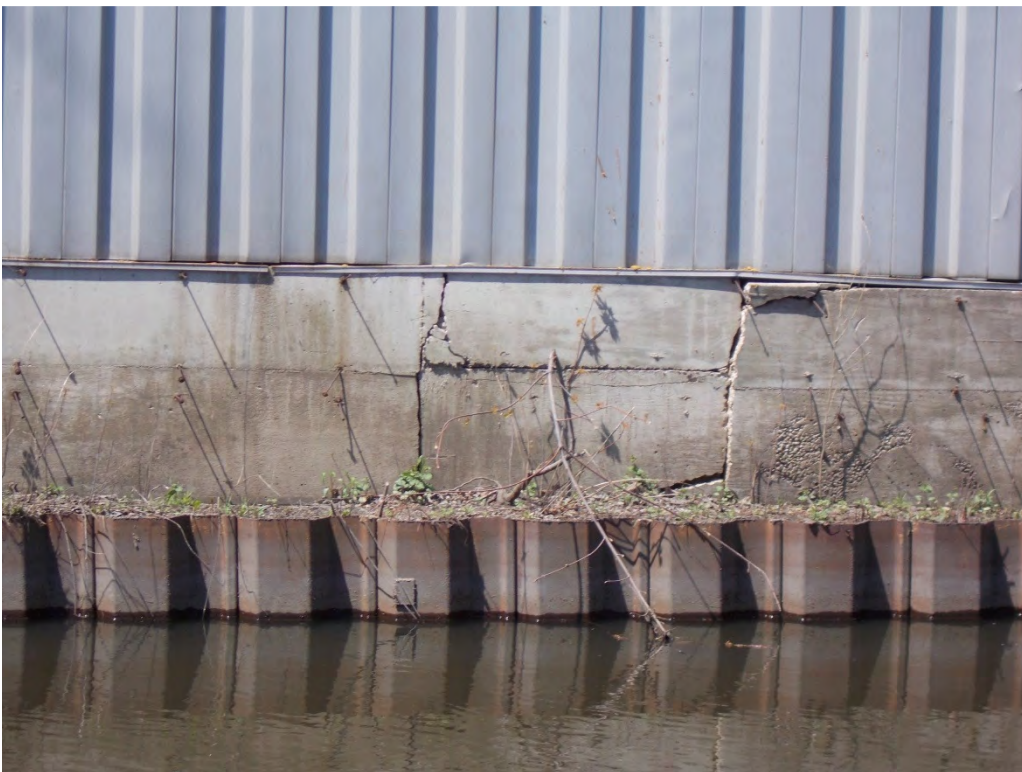
- The channel is 3.5-4.0 feet below the top of sheet pile.
- The concrete foundation wall has moderate honeycombing at pour joints. There is an area of critical vertical cracking with a 2" offset in the wall near the change in roof lines. There is a moderate vertical crack near the north end of the sheet pile.

View of area of critical cracking in concrete foundation from east bank

- Due to the limited sediment removal depth (approximately 1 foot), it should be possible to remove sediment against the sheet pile wall without disturbing it.
- It is recommended that the bank north of the sheet pile wall be left intact to avoid impacting the unknown foundation for the northern section of the building. If the bank cannot be left in place, a longitudinal cofferdam is recommended along the building with a minimum clearance of approximately 4 feet.
- Avoid excavation within 3-4 feet of the exposed concrete footing to prevent undermining or other disturbance.

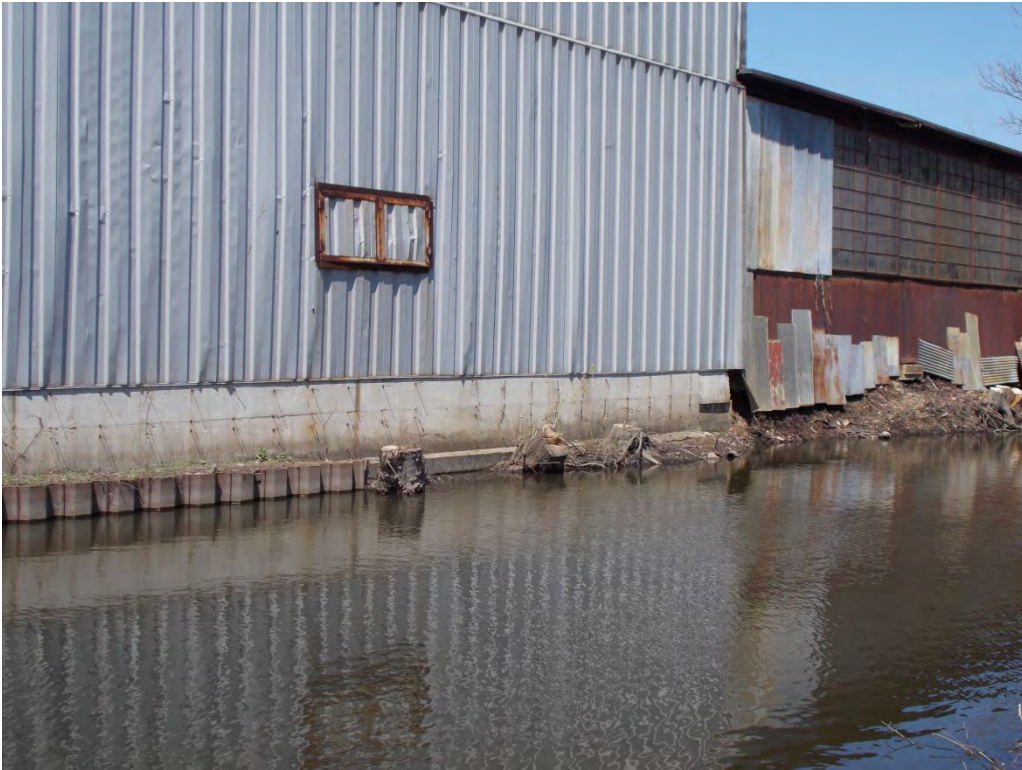
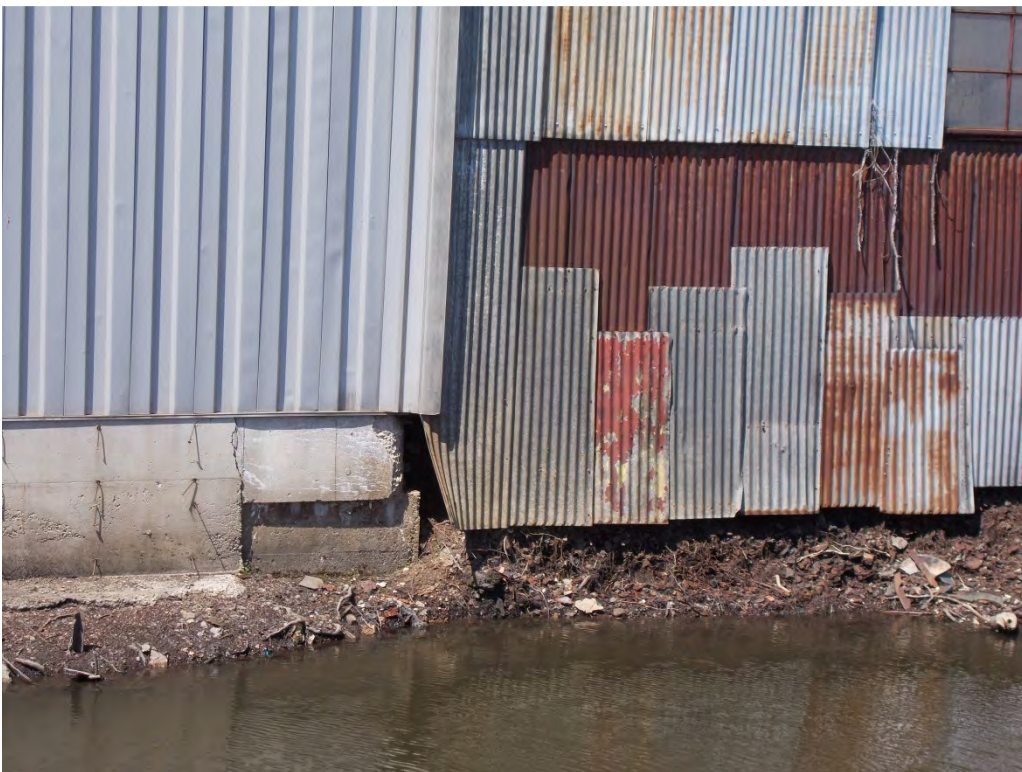
View of building transition from east bank

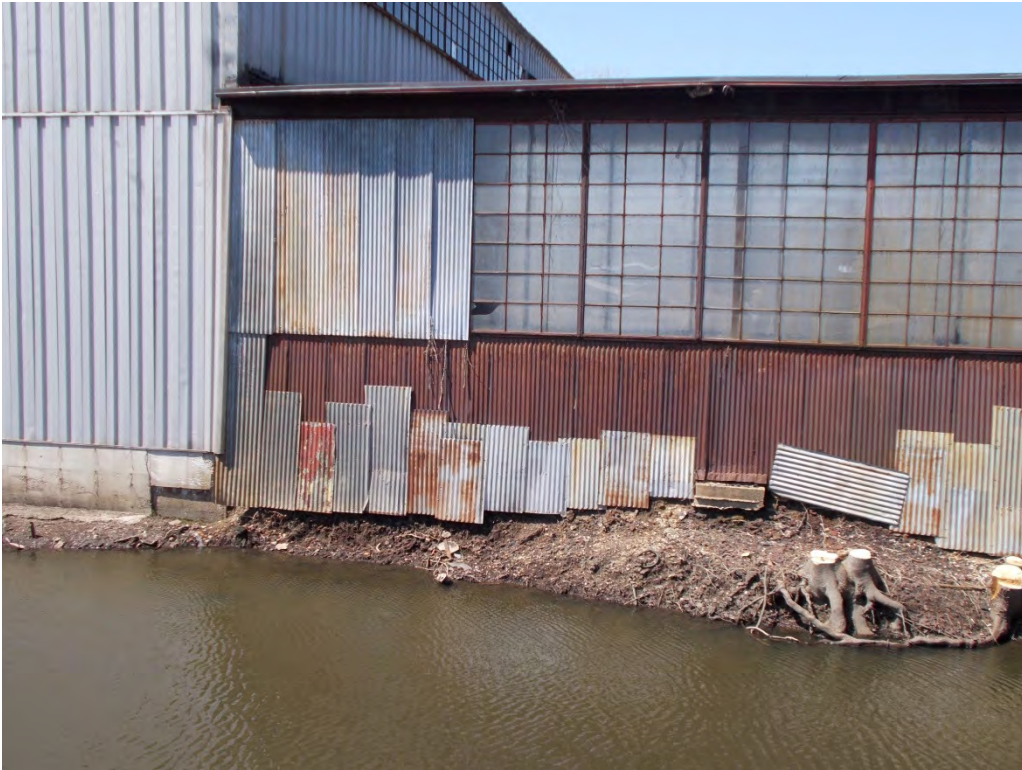
View of south end of northern section from east bank

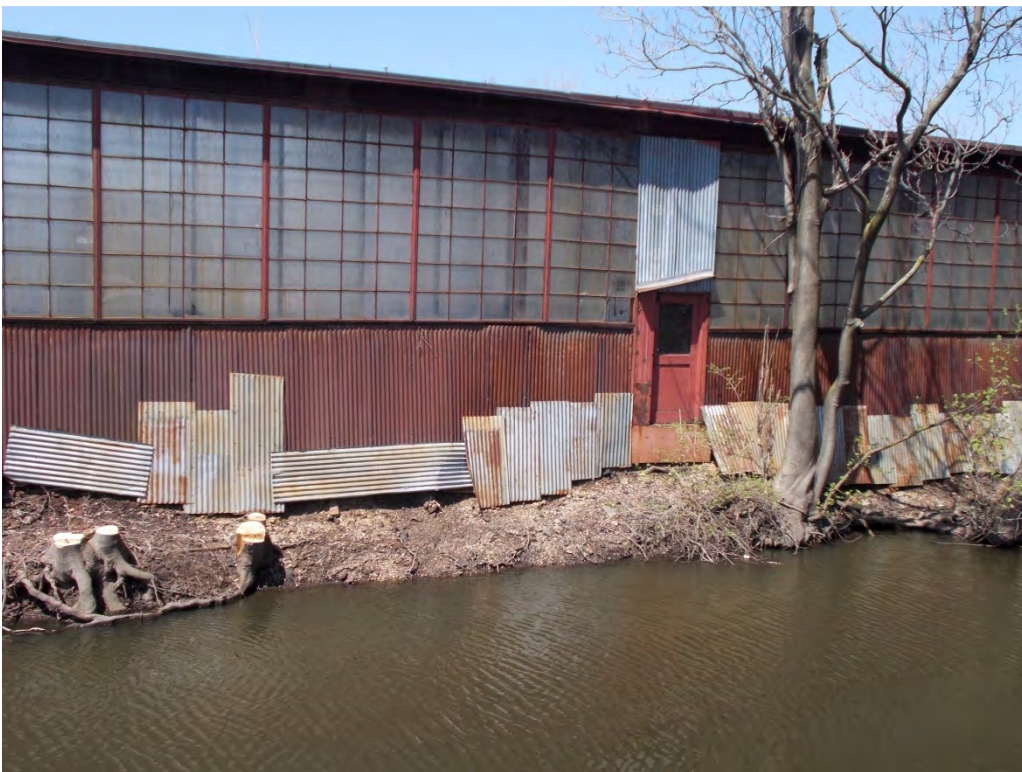
View of northern section from east bank

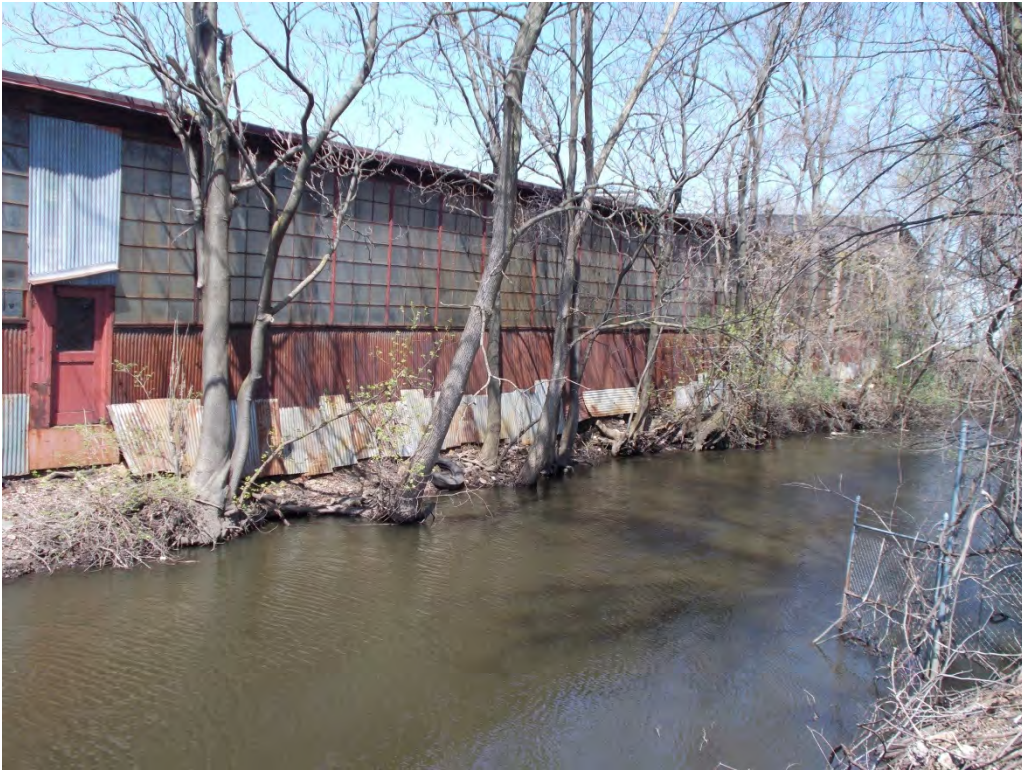
- The bank north of the sheet pile is mostly intact due to a series of large trees and stumps. The footing of the northern end of the concrete foundation wall is exposed approximately 8-12 inches.

View of trees supporting the west bank

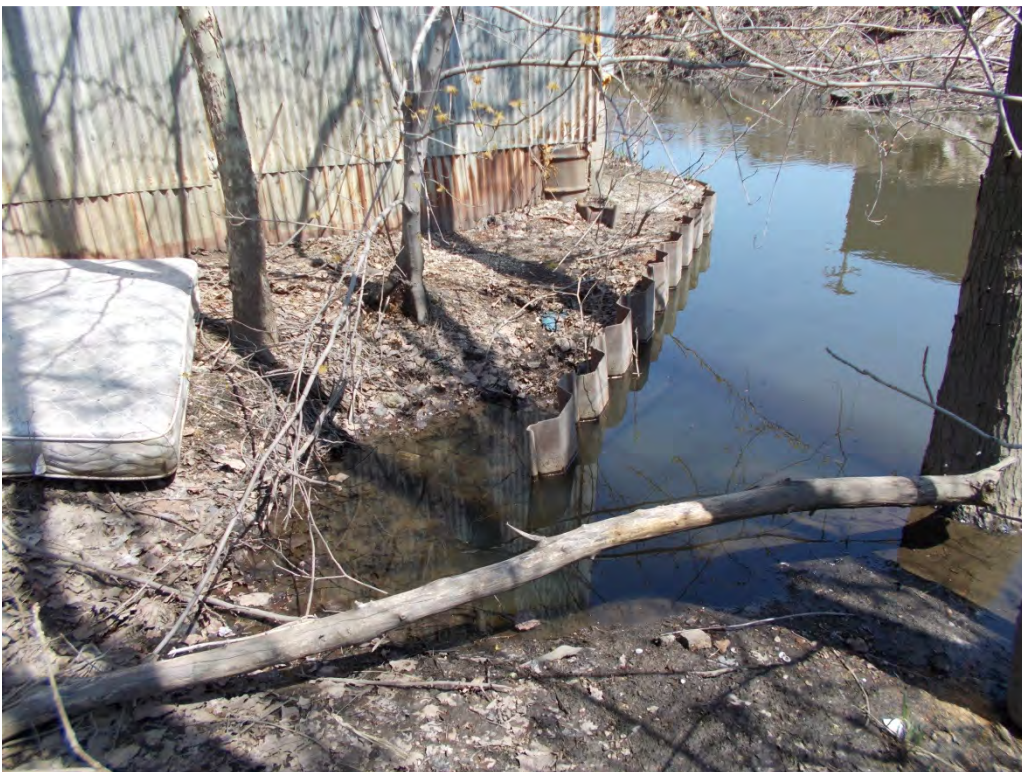
South end of sheet pile at southeast corner of building

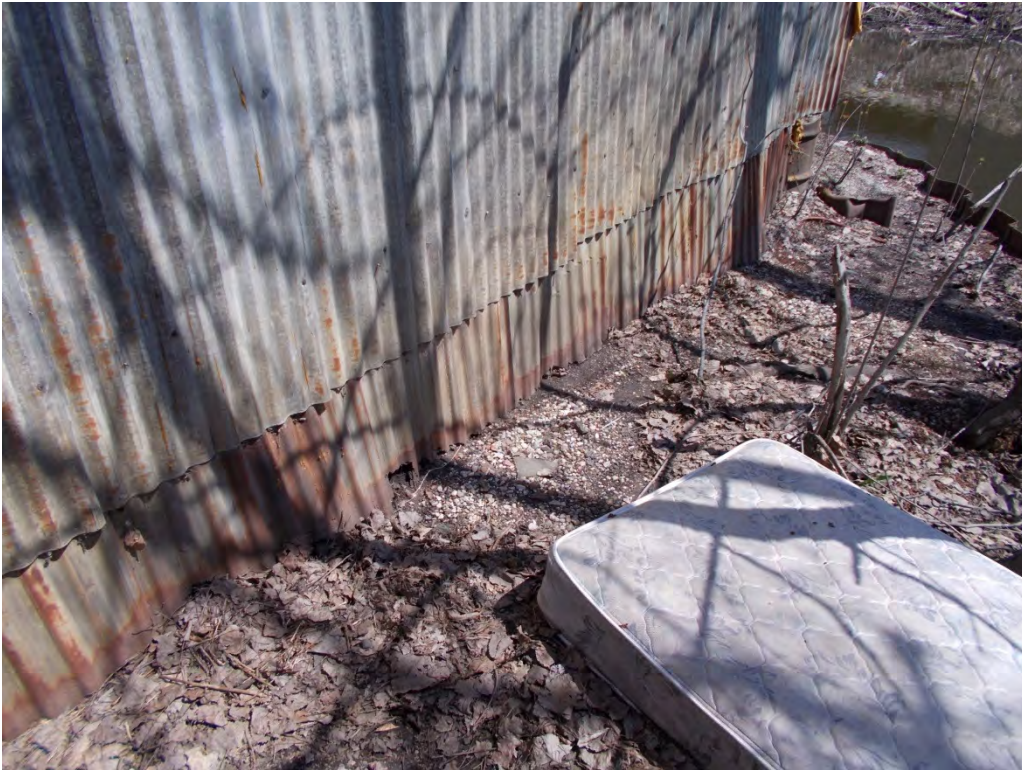
- The siding on the southern portion is buckled and damaged throughout.
- The corrugated siding on the northern section has moderate to severe surface corrosion. It is bent back near the transition between sections and generally in poor condition.

Corrugated siding on south face of building

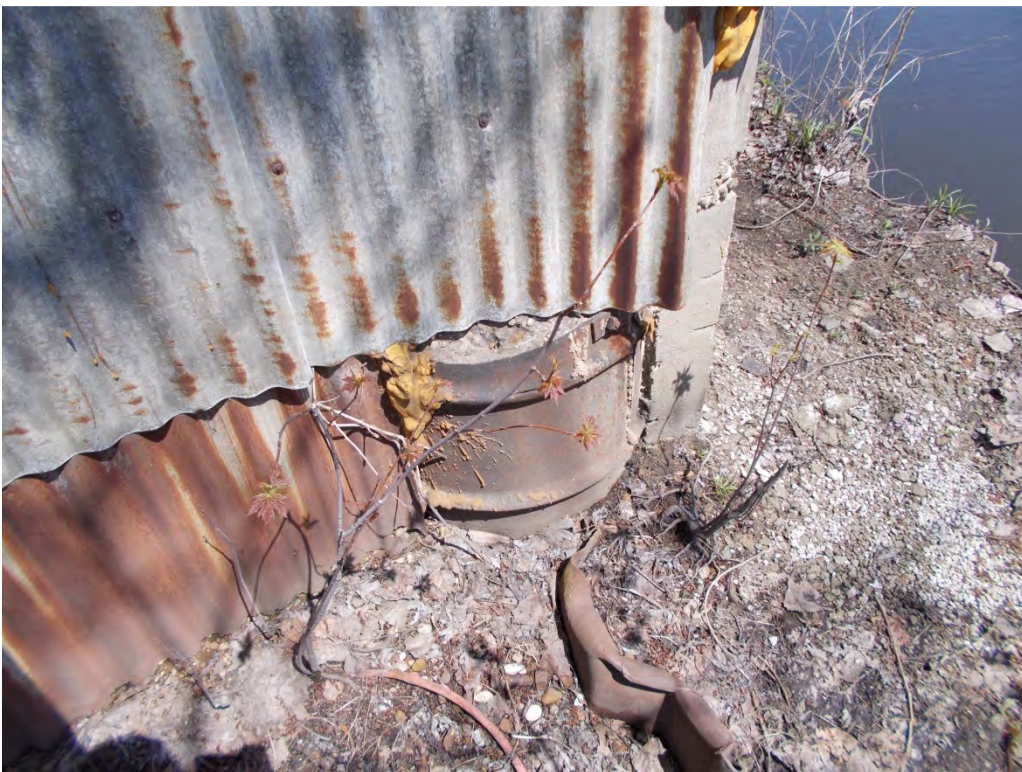
Suspected steel drum filled with concrete in southeast foundation

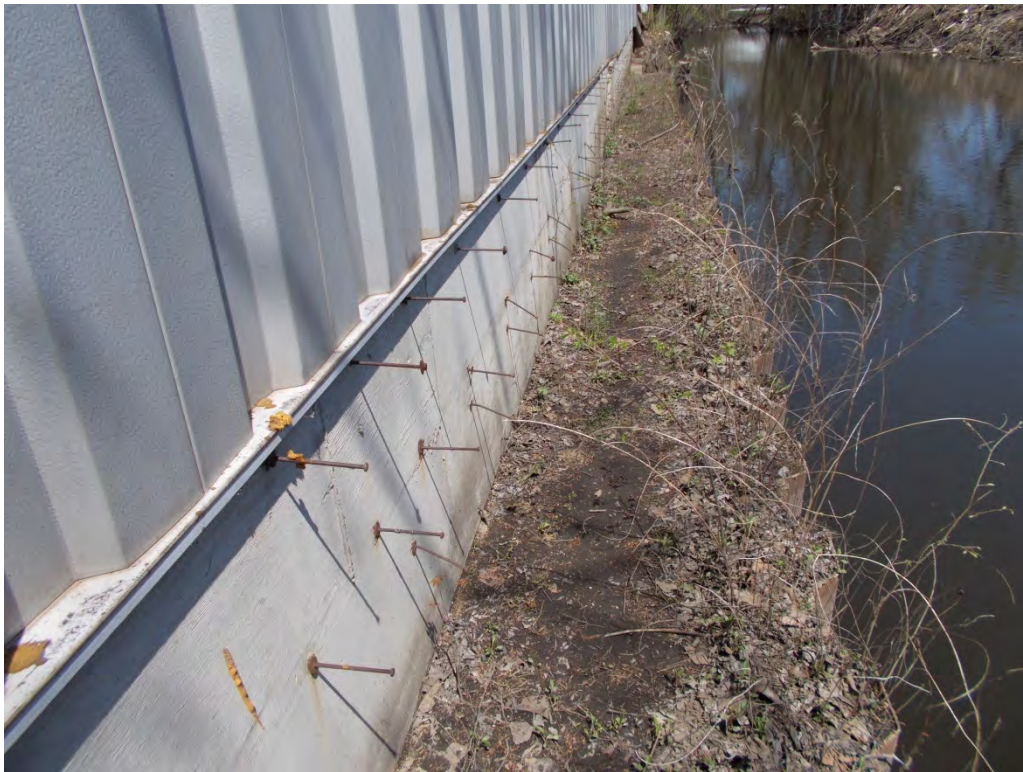
View of concrete foundation wall looking north

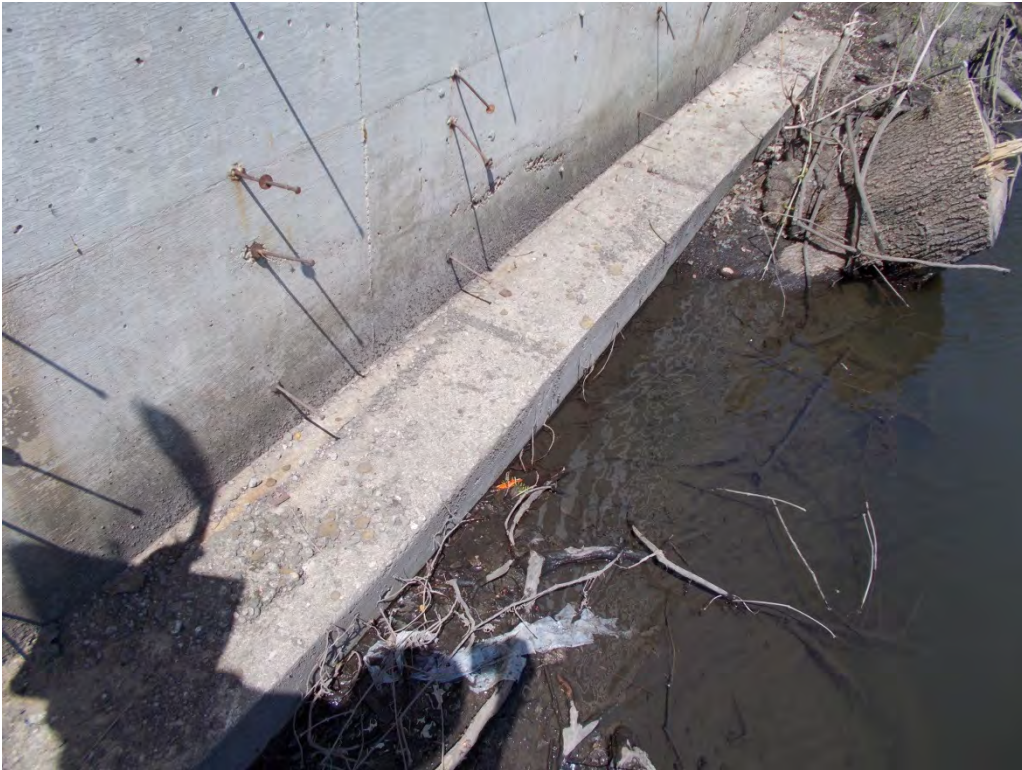
Exposed footing at north end of southern section of building

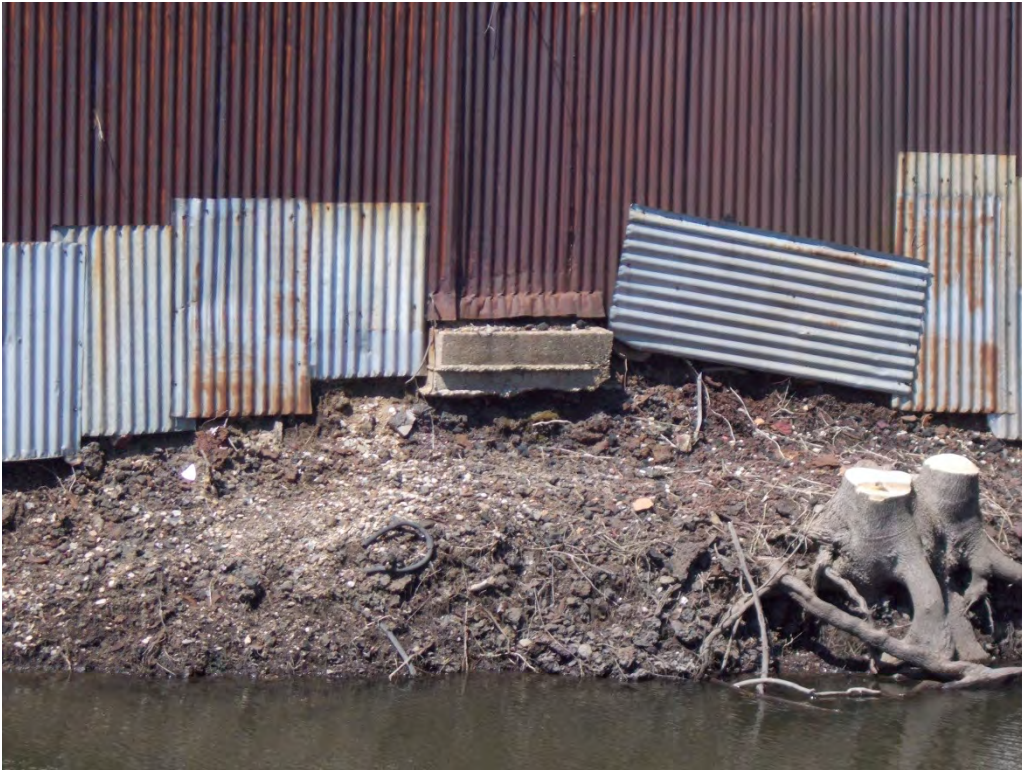
- There is an apparent column foundation in the northern section which is located well above the waterline and appears to be severely undermined.

View of suspected column footing in northern section looking north

View of suspected column footing in northern section from east bank

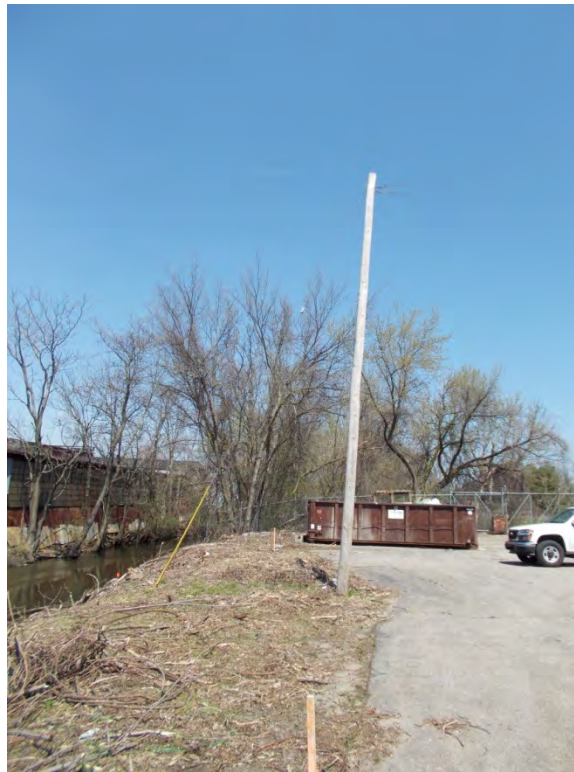
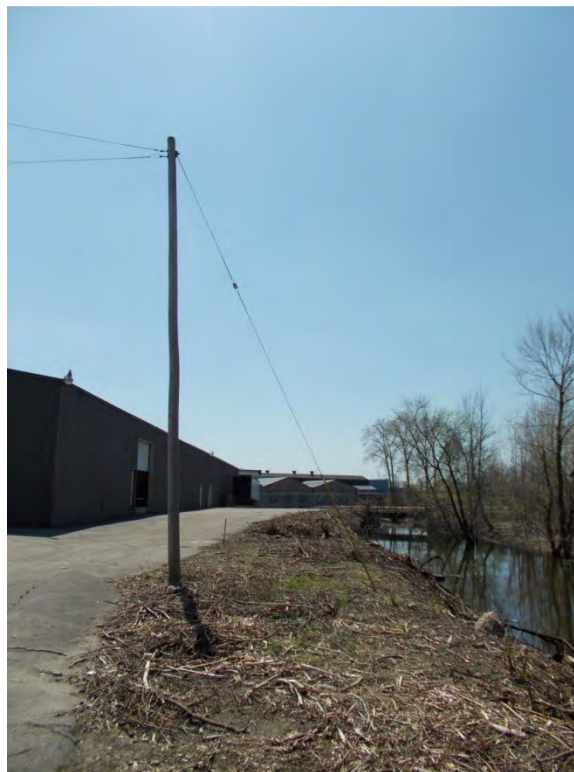
- The guy pole has a slight easterly lean.
- The pole and guy appear to be in fair condition.

View of the guy pole and wire looking north

View of the guy pole and wire looking south

- The guy pole and wire appear to be beyond the influence of the sediment removal in the area due to its shallow nature. Construction fencing or similar means should be used to identify the pole and guy to operators and drivers during the work.

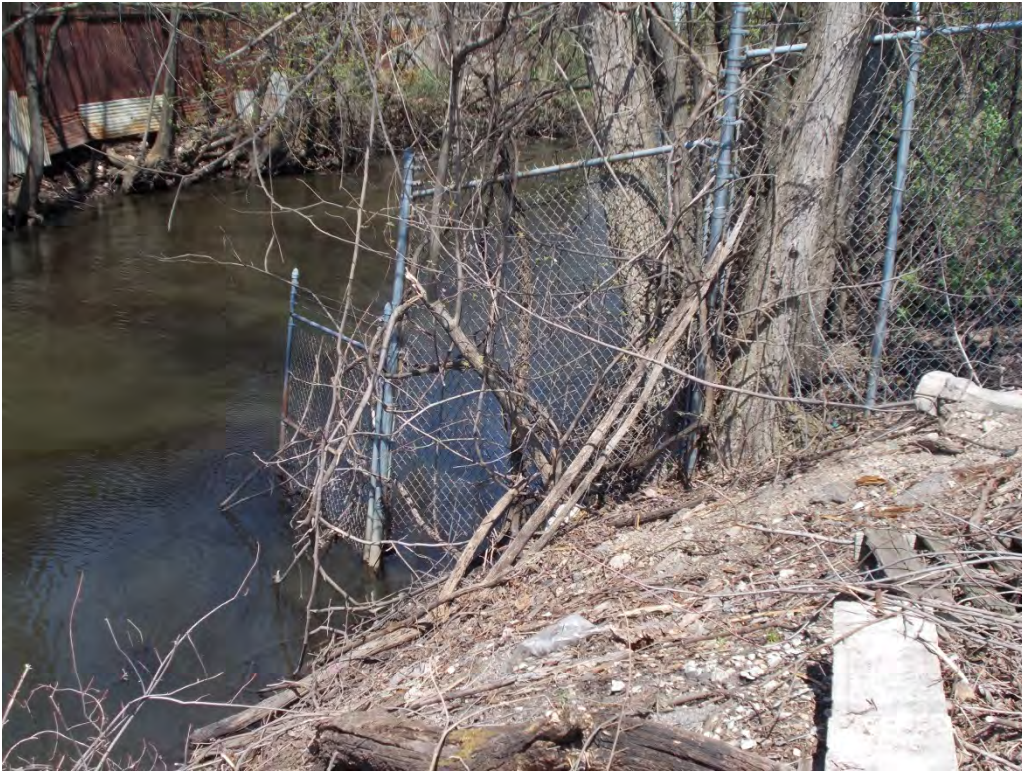
- The fence is in fair to good condition.
- The west end of the fence in the channel appears to be deflected to the north, presumably from impact by channel debris.

View of the fence looking north

- The fence is located north of SA1-B and is not likely to conflict with sediment removal operations. However, if the fence does conflict, it should be removed and replaced in kind.

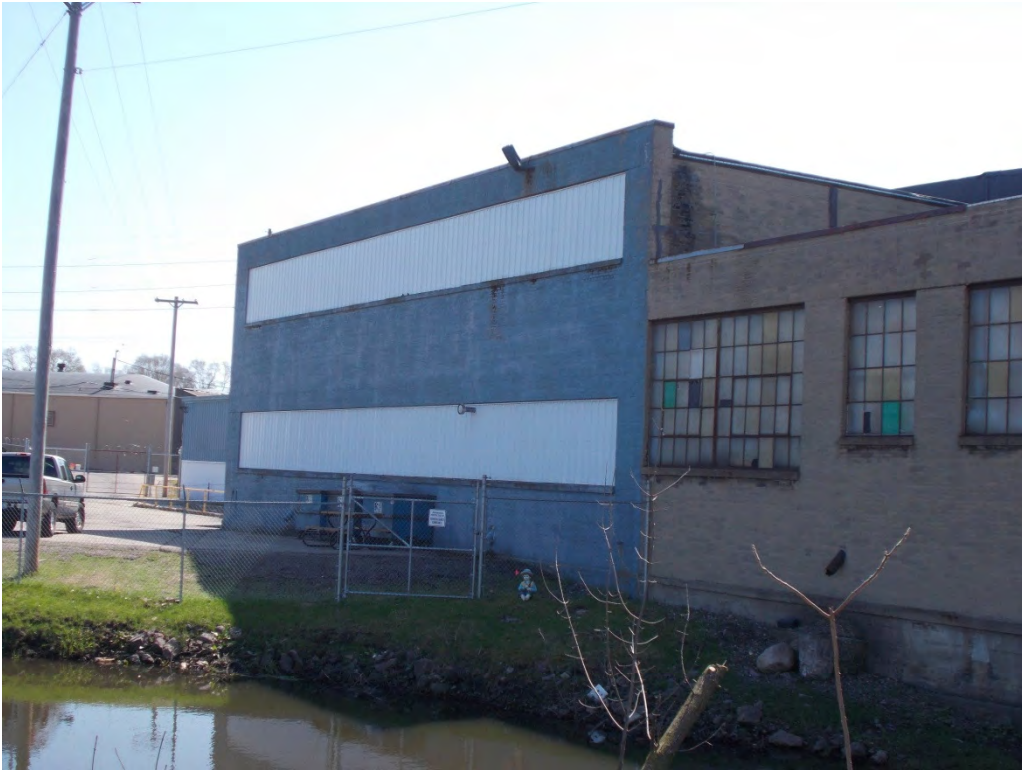
Structure: SA1-C-S01

View of structure from northwest

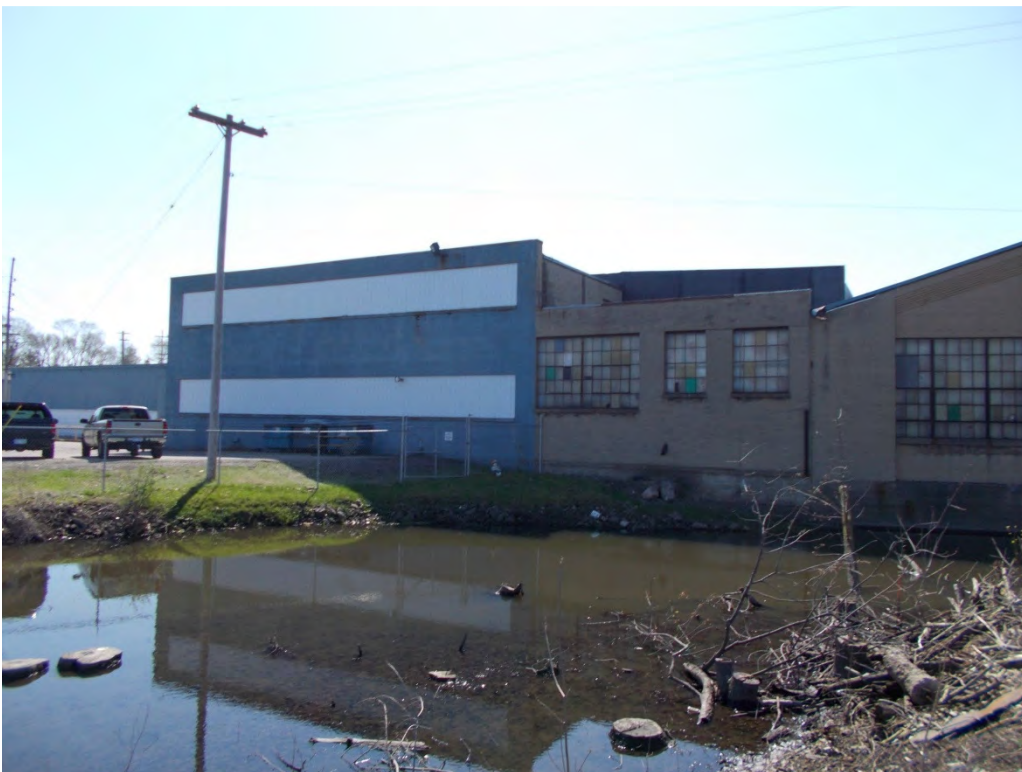
Overall view of structure from the north

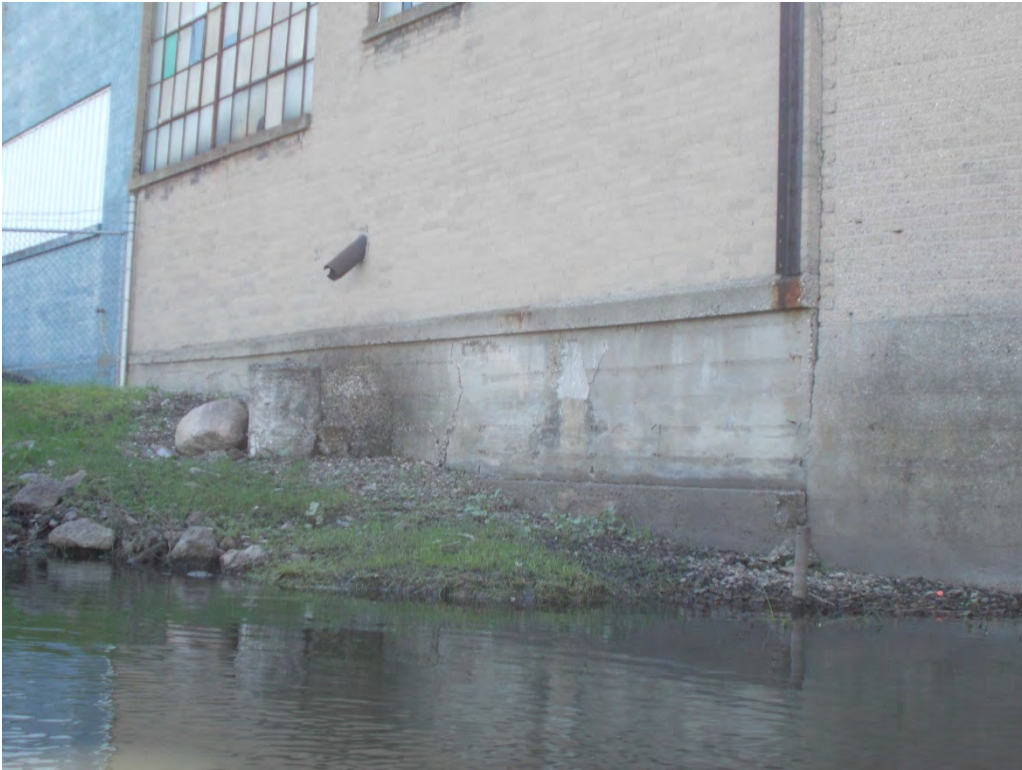
- Minor cracking, severe honeycombing and exposed form ties were noted in the concrete foundation wall.
- The footing is exposed upstream of SA1-C. Minor undermining was noted at the building transition.
- Moderate vertical and step cracking were noted in the brick. Cracking was noted in the primary wall and originating at window penetrations.
- A minor horizontal crack was noted between the concrete foundation and brick near the building transition.
- The eastern section of the building has sealed diagonal/step cracking near the fence line.
- Consumers Energy mapping shows a 2" gas crossing Portage Creek, however it appears to be west of SA1-C-S01 and outside the cofferdam limits.
- City of Kalamazoo mapping shows a water main crossing Portage Creek, however it appears to be west of SA1-C-S01 and outside the cofferdam limits.

Concrete foundation wall adjacent to the channel
